# Modelling for Roof Failure Analysis in an Underground Cave

M. Belén Prendes-Gero, Celestino González-Nicieza, M. Inmaculada Alvarez-Fernández

Digital Open Science Index, Mechanical and Mechatronics Engineering Vol:14, No:10, 2020 waet.org/publication/10011504

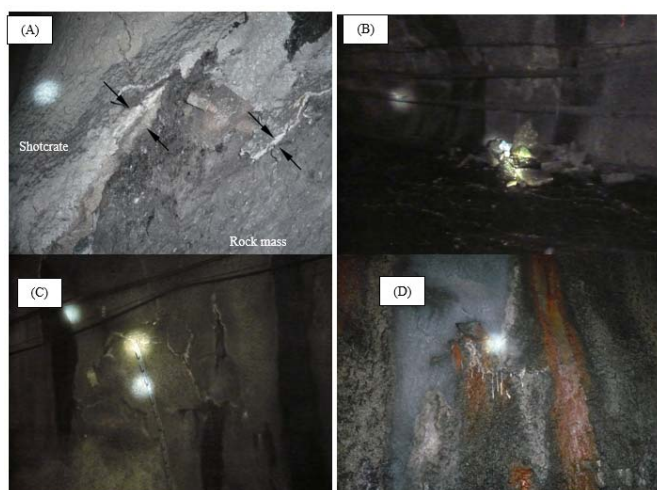
Along the ramp, when coal layers are crossed, the shotcrete support suffers a lot, because when this type of ground is deformed, it cracks and detaches the shotcrete. At some points it was found that the thickness of shotcrete was small and, in others, the shotcrete was not resting on the floor, if not "hung". These situations indicate that the shotcrete was not working properly as support. On the other hand, the infiltrating water produced oxidation problems in the bolts, as well as in the reinforcing fibbers of the shotcrete in the sections they were metallic. These problems are shown in Fig. 1. In some places, the support was reinforced by increasing the bolt density or installing new wood-clad metal frames (Fig. 2).

Fig. 1 Found problems in the shotcrete: (A) poor thickness, (B) detached blocks, (C) cracking, (D) leaks and oxidation

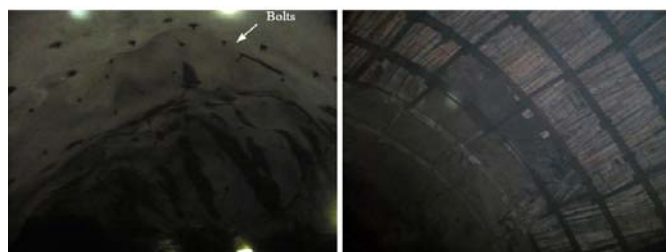
Fig. 2 Places with reinforced support in the ramp

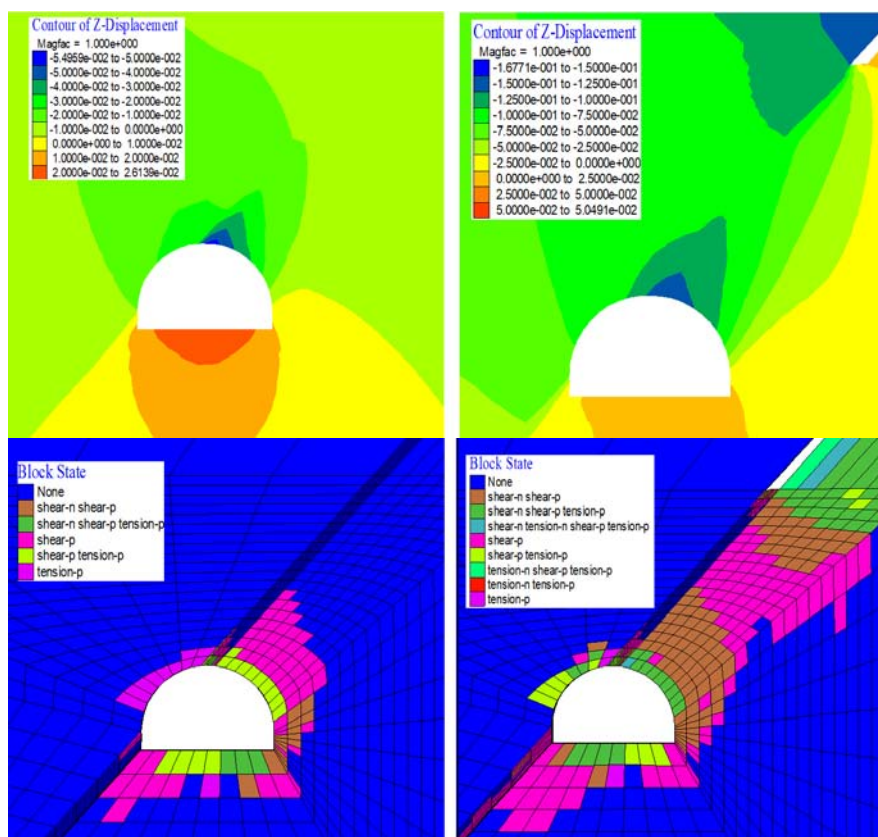
When the dimension of the tailgate is equivalent to the diagonal (14 m), the vertical displacements in the roof reach 5.5 cm and in the floor 2.5 cm. Again, is the wall of the layer the most affected placed with an increase in the fracturing and failure (Fig. 10).

Fig. 10 Vertical displacements and failure surrounding of the tailgate, before and after the exploitation for 14 m of diagonal

Once the workshop is exploited, the vertical displacements in the roof reach 15 cm, while the wall of the layer is totally plasticized between the tailgate and the workshop. There are very significant zones in the figure with a tendency to the break and/or landslide. This indicates that, if a landslide starts, it will take place in the wall of the layer and that the volume of involved material will be considerable, since the affected area has considerably grown compared to the previous situations.

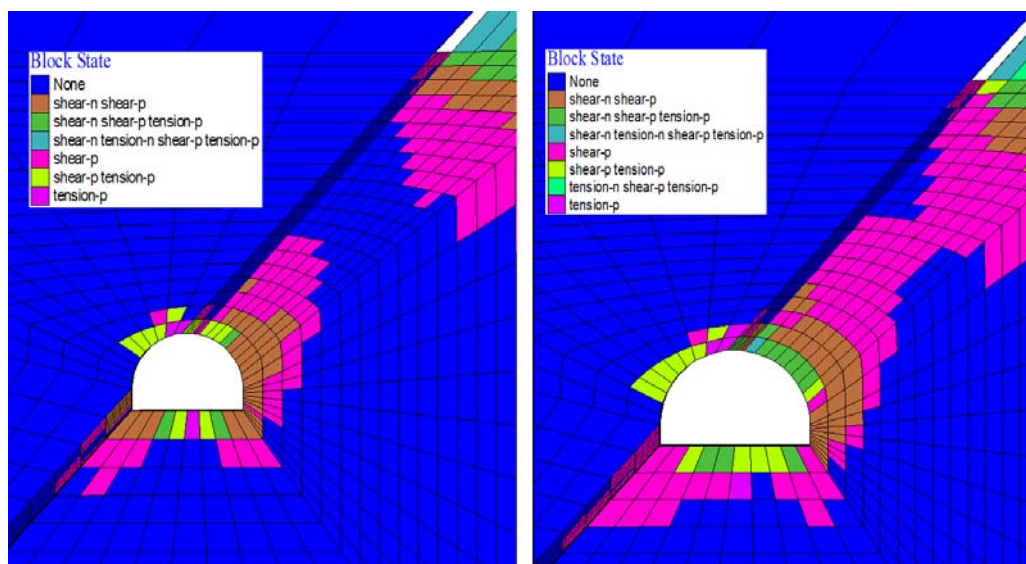
Protection pillars of 70 m could be suitable for gallery widths of up to 10 m (see Fig. 11), but they are insufficient when considering a gallery dimension equivalent to the

diagonal (14 m) because in this case, the plasticizing areas around the tailgate and the exploitation workshop appear again. On the other hand, with 80 m protection pillars, the plasticizing areas around the exploitation workshop and the tailgate are not connected (Fig. 12). Therefore, in case of one slide, it would be a local break in which the volume of material that can fall is much less and the support would

Fig. 11 Failure surrounding after the exploitation for 10 and 14 m and with protection pillar of 70 m

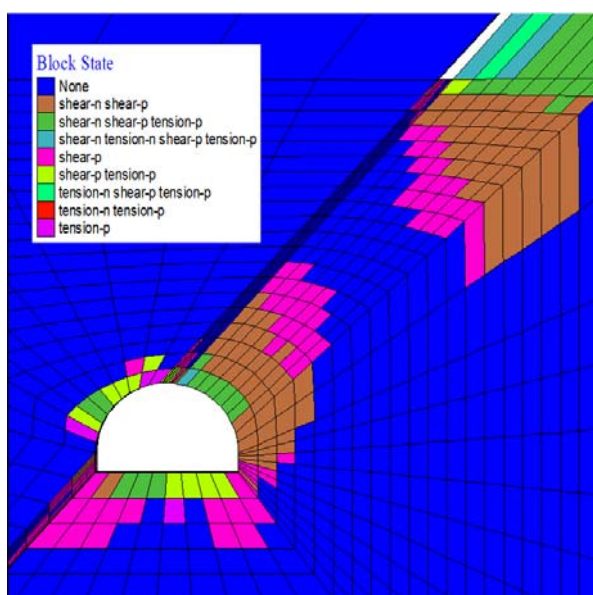
behave better. Based on these observations, it seems to be confirmed that the detachment was originated as a consequence of one sliding in the layer wall, due to the large roof span present in the place of the accident, and probably triggered as a consequence of the existence of a protection pillar insufficient.

Fig. 12 Failure surrounding after the exploitation for 14 m and with protection pillar of 80 m
