# Modelling for Roof Failure Analysis in an Underground Cave

M. Belén Prendes-Gero, Celestino González-Nicieza, M. Inmaculada Alvarez-Fernández

Digital Open Science Index, Mechanical and Mechatronics Engineering Vol:14, No:10, 2020 waet.org/publication/10011504

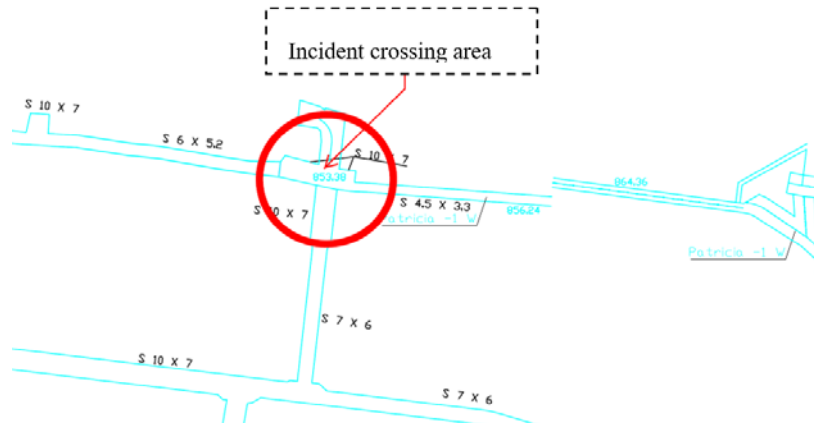
Fig. 5 Dimensions of the galleries in the collapsed area

- 1) Case 1: The tailgate has the most common dimensions in this type of infrastructure, that is to say, 6 m of width and 5.2 m of height.
- 2) Case 2: The tailgate has a bigger cross section, 10 m of width and 7 m of height. These dimensions are the dimensions of the collapsed place (Fig. 5).
